Thermography Inspection Report

Operator	
Location	conservatory
Equipment

Date	12th December 2008
Time	3.32 PM

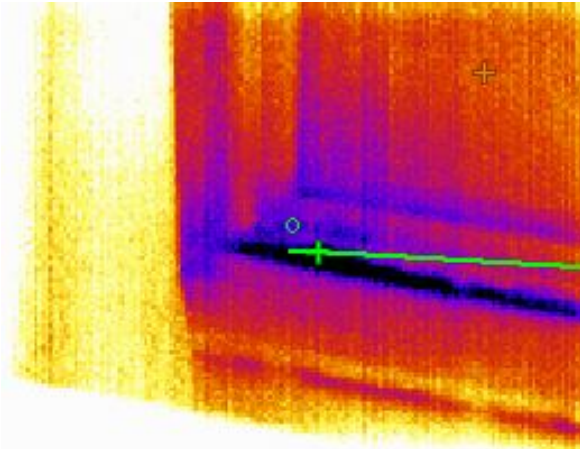
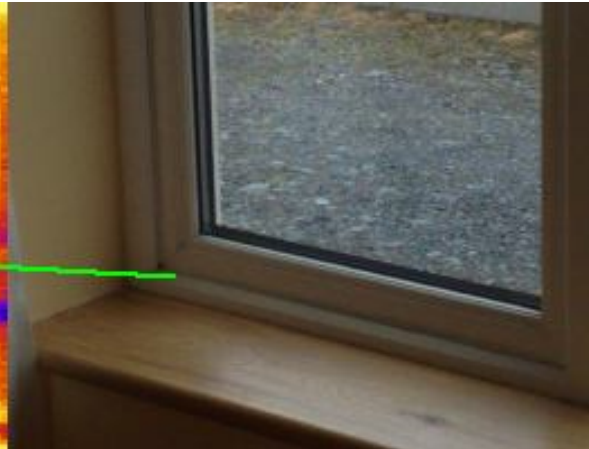
all windows in the conservatory when tested for air tightness using the blower door test showed significant signs of air penetration occurring under the frames and between sashes and frame when smoke tested, also the reveals indicate poor or missing insulation when thermally imaged.

Cursor 1	3.6 °C
Cursor 2	7.7 °C
Difference	-4.1 °C

4

all windows need to be sealed under frame between cill and and frame and all sashes need to be checked and adjusted.
